**M. M. Alzhigitova<sup>1</sup>**,  
orcid.org/0000-0002-3460-2531,  
**N. Tileuberdi<sup>\*1</sup>**,  
orcid.org/0000-0003-0781-2434,  
**M. R. Zapparov<sup>1</sup>**,  
orcid.org/0000-0003-4847-5278,  
**Y. S. Auyelkhan<sup>1</sup>**,  
orcid.org/0000-0002-7598-0088,  
**E. S. Abdisseit<sup>2</sup>**,  
orcid.org/0009-0000-3092-5096

## MONITORING OF LANDSLIDE PROCESSES IN THE ZHETYSU REGION

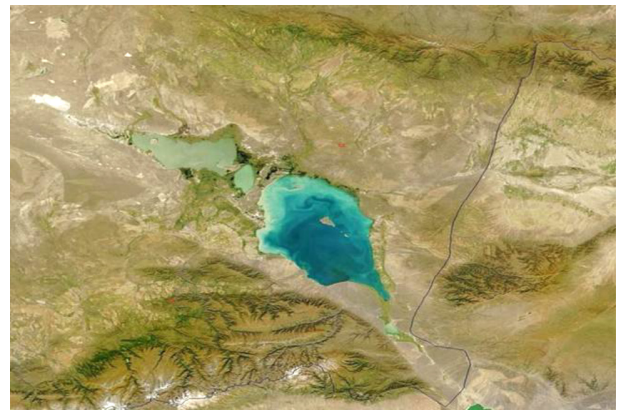
Fig. 1. Lake Alakol (Google Earth, 2021)

The Alakol Depression is an important object of study from the perspectives of geology, hydrogeology, and hydrology (Fig. 1). The issues related to the hydrogeological conditions of the region and its location within the system of fold structures of the Tien Shan have been extensively discussed in several studies [4].

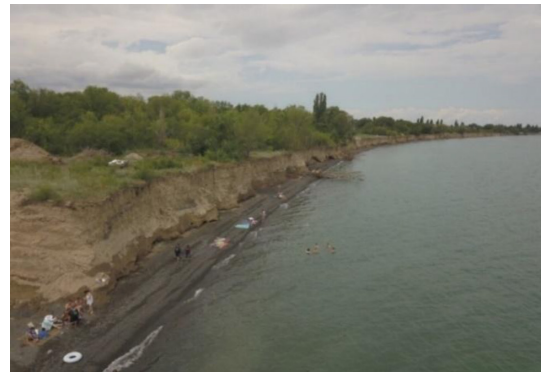
*Fig. 3. Results of shoreline erosion (photo by the author, 2020)*

In one scientific paper related to the research on the Alakol depression, it is suggested to conduct bathymetric surveys, assess the thickness of underwater deposits on the beach, determine their area and composition [20]. It is also recommended to establish the age of the beach gravels and the loess-like silty clays covering them. In addition, it is important to perform a paleogeographic analysis of the formation and development of Lake Alakol and its depression in order to reconstruct changes in the shoreline in the past (Figs. 3–6).

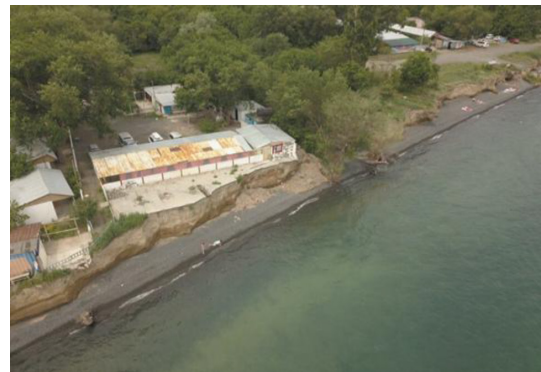
*Fig. 4. Results of shoreline erosion at Akshi village (photo by the author, 2019)*

Instrumental measurements were conducted at the monitoring site located to the northwest of Akshi (Fig. 7). The distance from 4 reference points (observation points) to the edge of the shoreline cliffs at Lake Alakol was measured (Fig. 4).

1. The dynamics of the retreat of the shoreline cliff edge at reference point I over 10 months (2018–2019) amounted to 6.5 m, at reference point II – 6.3 m over the same period, at reference point III – 6.4 m, and at reference point IV – 6.7 m. The distance from reference point I to the cliff edge is 19.5 m.

2. The width of the beach (from the waterline to the base of the cliff) is 3–3.2 m. The beach is composed of coarse-grained dark-colored sand (almost black) and a gravelly-pebble mixture. Dry soil and fragments of collapsed material from the cliff edge are also found in some areas.

3. The height of the cliff at this monitoring site is approximately 0.7–2 m.

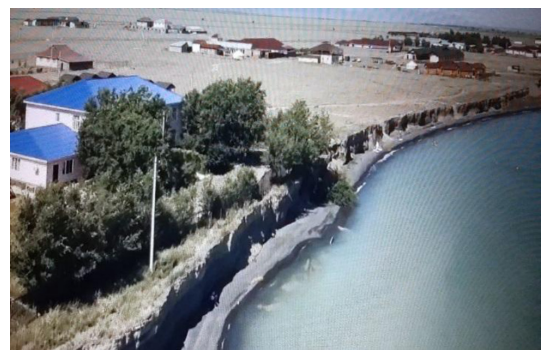
*Fig. 5. Shoreline abrasion (photo by the author, 2019)*

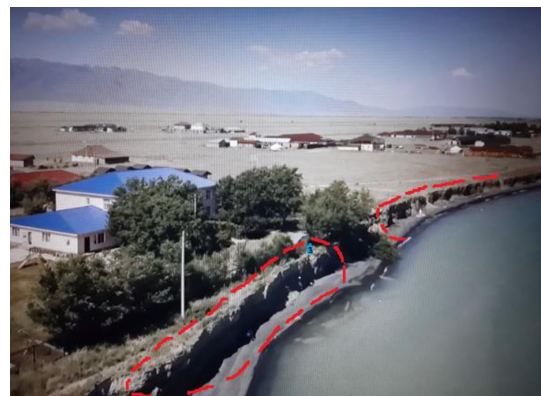
*Fig. 6. Shoreline abrasion (photo by the author, 2019)*

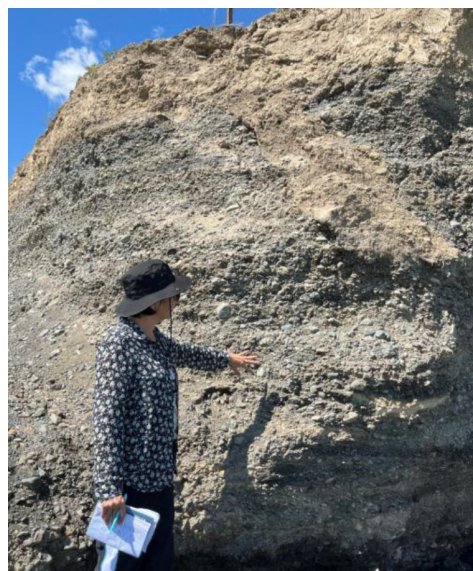
Fig. 8. Results of shoreline erosion at Akshi village (photo by the author, 2024)

During the research, the following areas were identified as being susceptible to natural processes of shoreline erosion due to natural geological and geomorphological factors, as well as active destruction of the coastline resulting from anthropogenic interference (Figs. 7, 8).
